Sand Lake Inlet/Outlet

MDNR ID #02269

Inspection conducted June 18, 2015
Act 451 P.A. of 1994 Part 307

SAND LAKE LEVEL CONTROL STRUCTURE

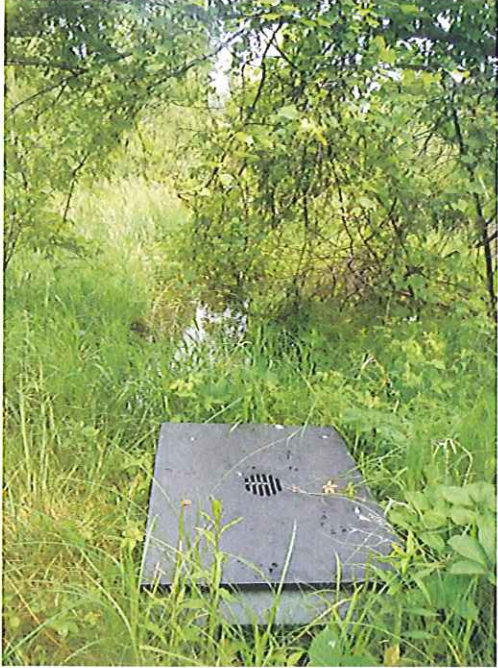
North Side US-12 Control Structure

STOPLOG VALVES AND GATES (open and close to check condition): Check location of top stoplog in relation to top of riser pipe intake box or fixed crest, for leakage, and condition of stoplogs, valves and gates.
Stop logs are metal at the outlet structure and are in good condition. WSEL 0.3 feet above reference mark above crown of pipe.

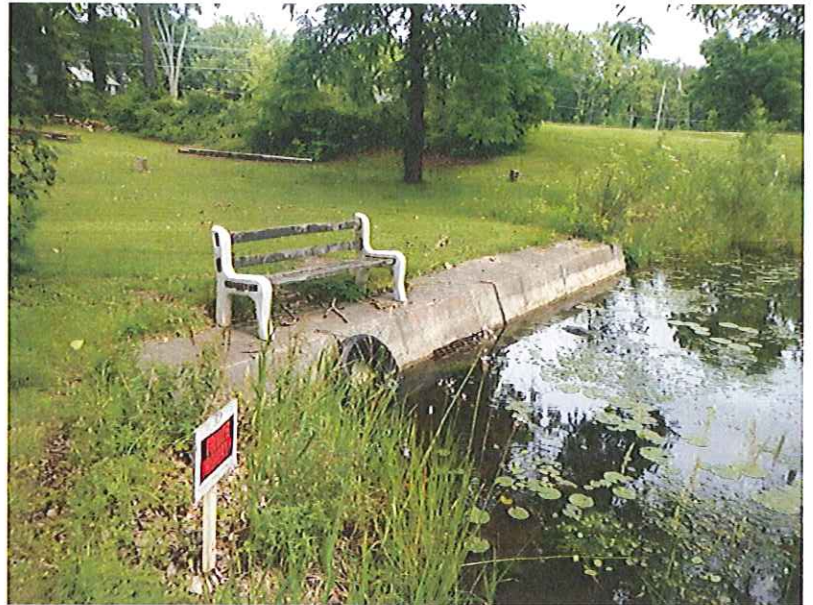
South Side of US-12 Structure

OUTLET PIPE: Check for damage from ice, logs, vandalism; inside discharge pipe for settlement and/or joint separation; condition of pipe coating. New 21" HDPE installed in 2002. Overall in good condition. Some minor debris on south end at inlet side.	
CONCRETE STRUCTURE: Check for erosion; location of cracking or spalling. If old or new; settlement; need for crack repairs. Concrete headwall on south end (inlet) is in fair condition. No visible signs of cracks or settlement of structure.	
WALKWAY & RAILING: Check if in place or removed, condition, and if adequate protection provided. None	TRASHRACK OR LOG BOOM: Check if operable. N/A
EMERGENCY SPILLWAY: Size, type, and condition. N/A, none exists

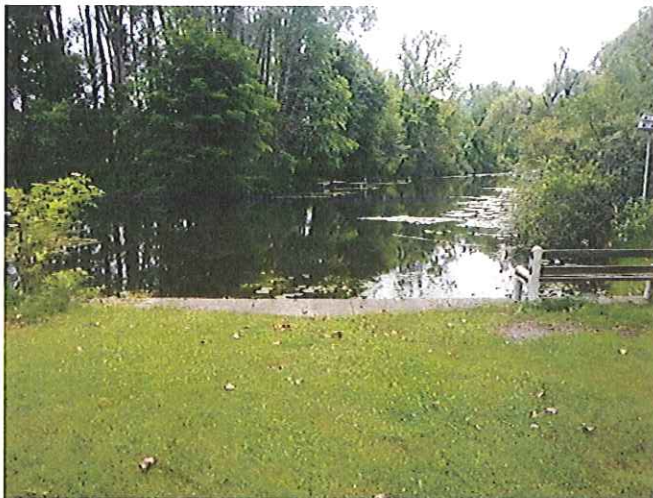
South Side of US-12 Looking Upstream

INLET	OUTLET
SIZE	Open channel from sand lake. 30+ feet wide, 1000-foot long	Small swale (2-3 feet wide) through wetland area
EXISTING CONDITION	Fair, some debris collects near inlet, should be monitored	Good
EROSION	None	None
DEBRIS & OBSTRUCTIONS	Tire, metal grate near....nothing blocking flow	None
RIPRAP PROTECTION	None, headwall in place so nothing needed	None
REMARKS*	Overall in fair condition	Overall in good condition
