Posey Lake Outlet

MDNR ID #02265

Inspection conducted June 18, 2015
Act 451 P.A. of 1994 Part 307

MICHIGAN DEPARTMENT OF ENVIRONMENTAL QUALITY
LAND AND WATER MANAGEMENT DIVISION
DAM INSPECTION REPORT

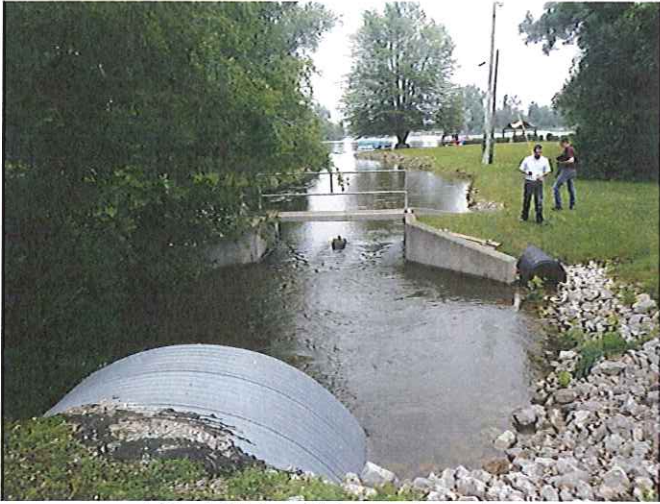
West Side of Posey Lake Dam

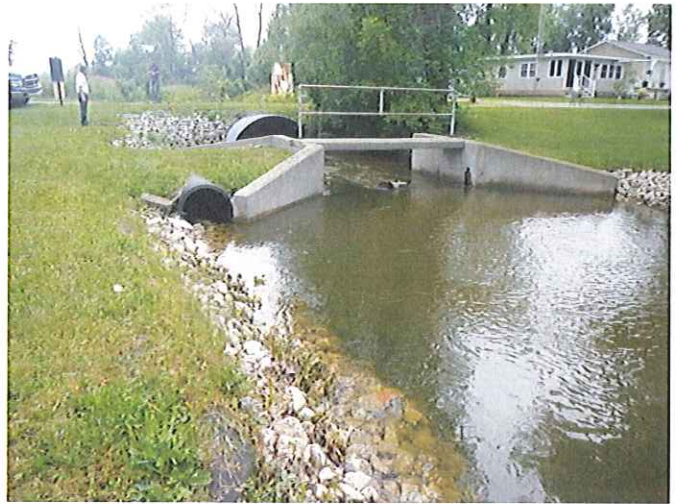
East Side of Posey Lake Dam

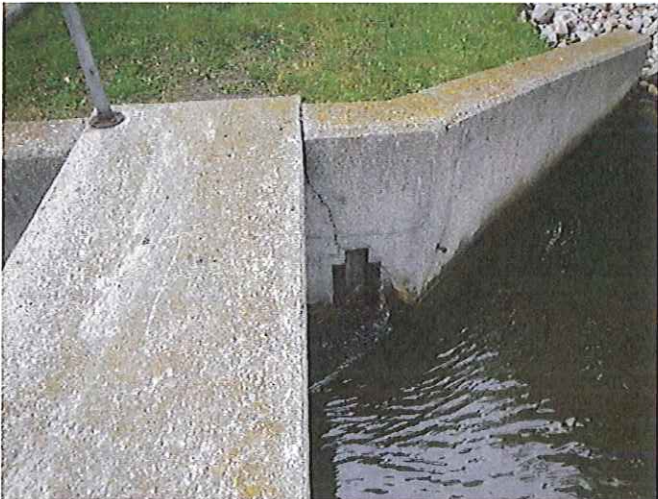
CONCRETE STRUCTURE: Check for erosion; location of cracking or spalling. If old or new; settlement; need for crack repairs. Overall in Fair condition. Prior inspection reports indicated surface cracks on the northeast wall and in the northwest footer. Cracks were reported in these reports as not critical and were just to be monitored. Based on previous inspection reports and photos, both these cracks do not appear to be getting any wider or larger and the ground around these areas does not appear to be settling. A benchmark was set up by the LCDC's office to monitor settling and these cracks.

Crack-Northeast Side

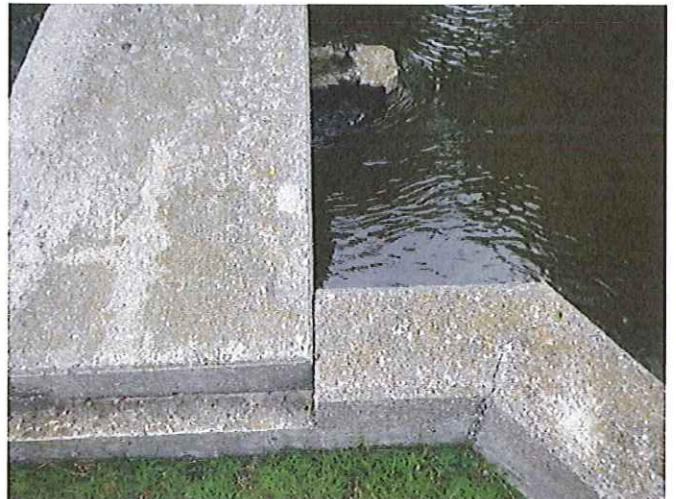
WALKWAY & RAILING: Check if in place or removed, condition, and if adequate protection provided.
The concrete walkway appears to be shifted slightly. Monitor this to see if it continues to shift.

Crack-Southeast Side; Shows walkway shifted slightly
