Devil's Lake Outlet

MDNR ID #01976

Inspection conducted June 18, 2015
Act 451 P.A. of 1994 Part 307

**MICHIGAN DEPARTMENT OF ENVIRONMENTAL QUALITY
LAND AND WATER MANAGEMENT DIVISION
DAM INSPECTION REPORT**

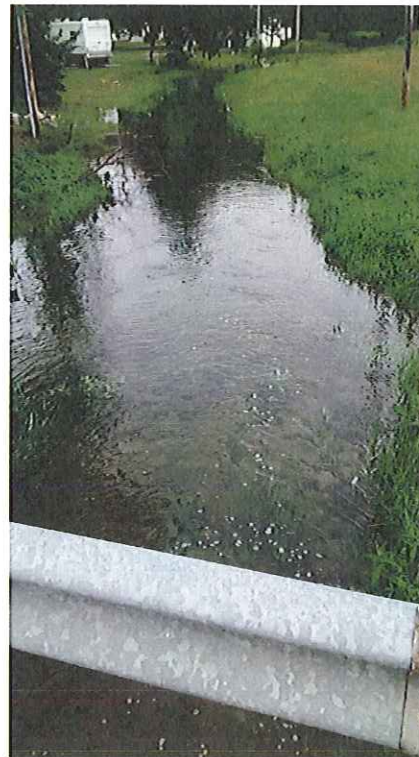
INLET	OUTLET
SIZE	Approx. 60 to 70 feet wide channel. Some wave action from use of lake by boat traffic.	Channel is less than 30 feet wide. Some rip rap in channel and downstream of spillway.
EXISTING CONDITION	Good	Good
EROSION	None	None
DEBRIS & OBSTRUCTIONS	None	None
RIPRAP PROTECTION	Yes	Yes
REMARKS*	Good condition	Good condition

Looking downstream at outlet channel
