Cambridge Lake Outlet

MDNR ID #711

CAMBRIDGE LAKE LEVEL CONTROL STRUCTURE

**MICHIGAN DEPARTMENT OF ENVIRONMENTAL QUALITY
LAND AND WATER MANAGEMENT DIVISION
DAM INSPECTION REPORT**

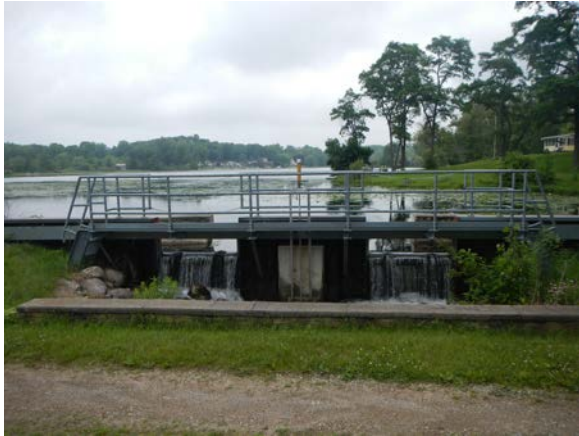
Downstream side of structure
(Looking north)

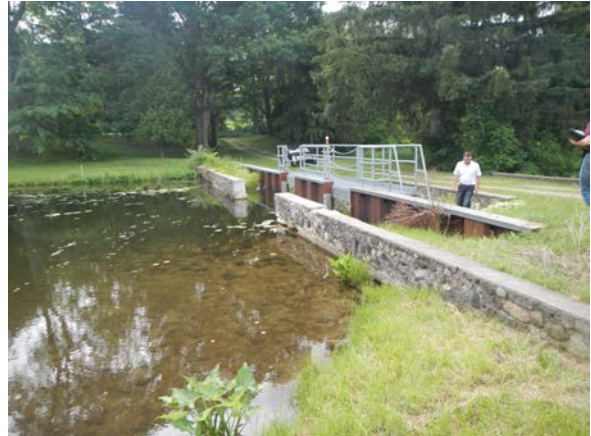
Upstream side of structure
(Looking east)

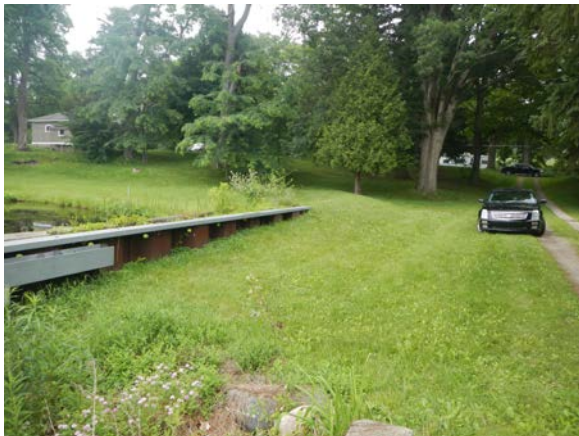
East embankment
(Looking east)

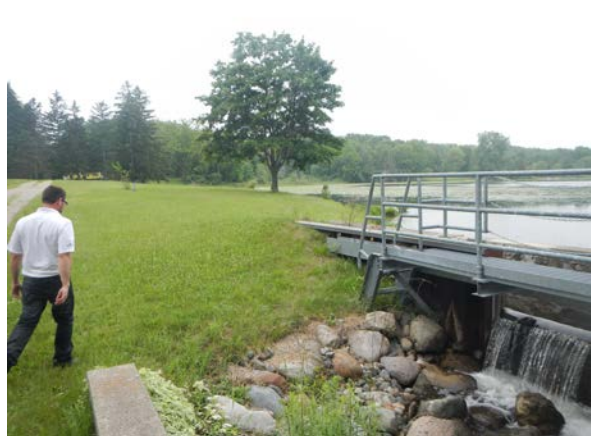
West embankment
(Looking west)

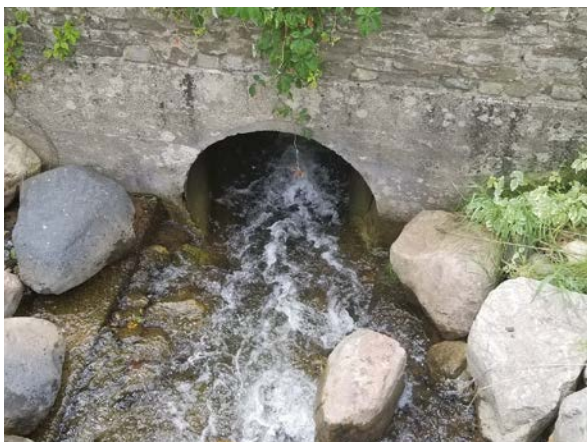
<p>OUTLET PIPE: Check for damage from ice, logs, vandalism; inside discharge pipe for settlement and/or joint separation; condition of pipe coating. 42" inch cnp culvert set in concrete footing base of private drive. Pipe culvert in good condition and was used in the redesign of the new outlet structure in 2010.</p>	
<p>CONCRETE STRUCTURE: Check for erosion; location of cracking or spalling. If old or new; settlement; need for crack repairs. Not a concrete structure for the control structure. The headwall and opening upstream of the control structure appears in good condition with no major cracking. The metal control structure is showing signs of oxidation and should be monitored closely.</p>	
<p>WALKWAY & RAILING: Check if in place or removed, condition, and if adequate protection provided.</p> <p>Good condition. Metal walkway and railing</p>	<p>TRASHRACK OR LOG BOOM: Check if operable.</p> <p>Good condition</p>

Inlet pipe under private drive crossing
(On South side, looking north)

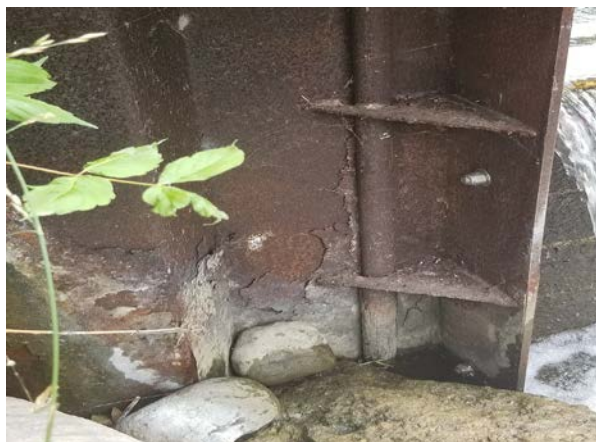
STOPLOG VALVES AND GATES (open and close to check condition): Check location of top stoplog in relation to top of riser pipe intake box or fixed crest, for leakage, and condition of stoplogs, valves and gates.
Good condition. All Valves and gates were constructed in 2010, the metal gate components are showing signs of oxidation on the west end and should be monitored closely.

Oxidation of metal gate components
(West side)

INLET	OUTLET
SIZE	16-foot wide concrete headwall approx. 5 feet upstream of control structure.	42" culvert under private drive downstream of control structure. Channel downstream of culvert is 15+ feet wide.
EXISTING CONDITION	Good	Good
EROSION	None observed	None observed
DEBRIS & OBSTRUCTIONS	None observed	None observed
RIPRAP PROTECTION	Yes, good condition	Yes, good condition
REMARKS*	Good condition, monitor metal components of control structure to ensure integrity is not lost due to oxidation.	Good condition
